REGAL THEATRE CONSERVATION MANAGEMENT PLAN

REPORT NAME:	REGAL THEATRE CONSERVATION MANAGEMENT PLAN (UPDATE)
FOR:	CITY OF BURNSIDE
JOB NUMBER:	19014

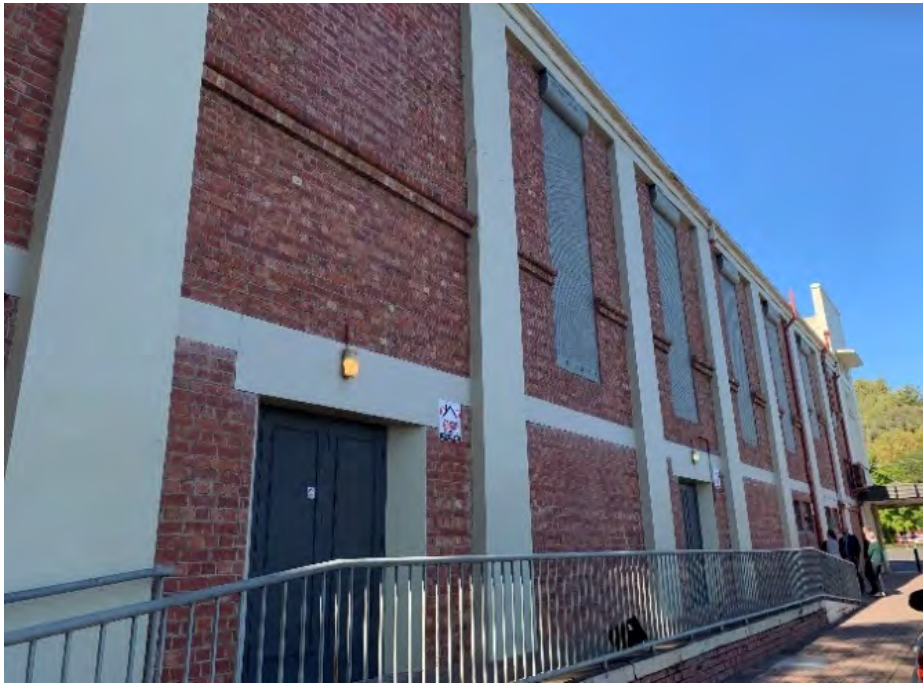
Figure 7: West elevation – note expressed concrete piers (GGA, 2019)

The primary item requiring investigation is the cracking to concrete columns, particularly on the western elevation, where corrosion of the reinforcing within the concrete may be occurring. High level access will be required to undertake some destructive testing, to determine the exact nature of the problem, and prepare a repair scope of works.

The expressed concrete columns should be retained and conserved. An investigation and repair works package should be scoped for the reinforced concrete frame (columns and beams).

An inspection and repair scope of works is being developed to review the condition of the concrete columns, and provide remediation recommendations. Beyond any specific repairs to be undertaken as a result, all concrete should be monitored in a regular and ongoing manner to ensure no breakdown in the cover over reinforcing structure.

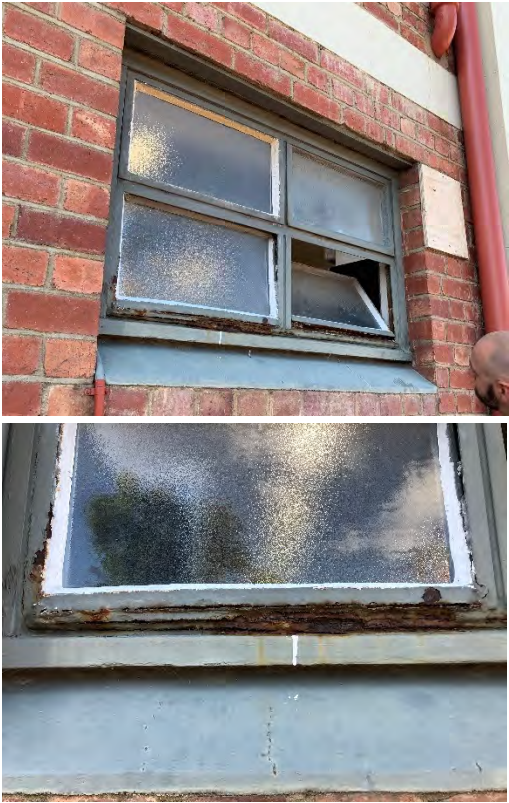
Item	Image	Recommendation
Roof	-	Detailed roof inspection required to determine if continued water ingress is occurring and identify locations
Steel windows

Remove corroded sections and replace; treat entire frame and sashes with anti corrosion treatment and repaint with appropriate paint system
Timber doors	 	Repaint doors externally; install new door seals as required

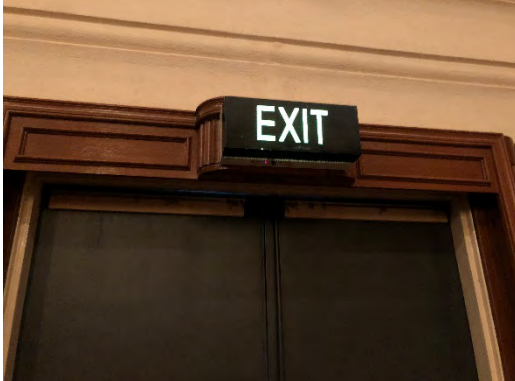
<p>Newer exit signs have been installed which conceal original detail. Can be retained, or explore other options to reinstate original</p>
<p>Auditorium 1941 decorative plaster elements</p>

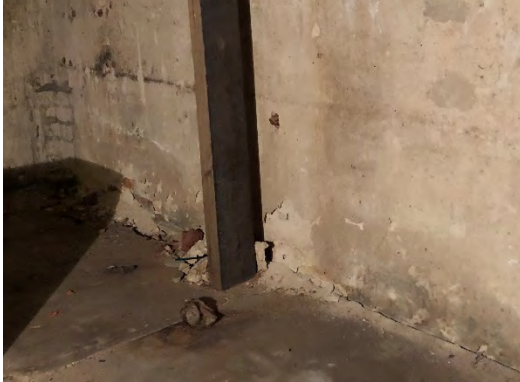
<p>Monitor salt damp to base of walls, consider long term repair scope for rendered masonry walls</p>
<p>Sub-stage area – services</p>
